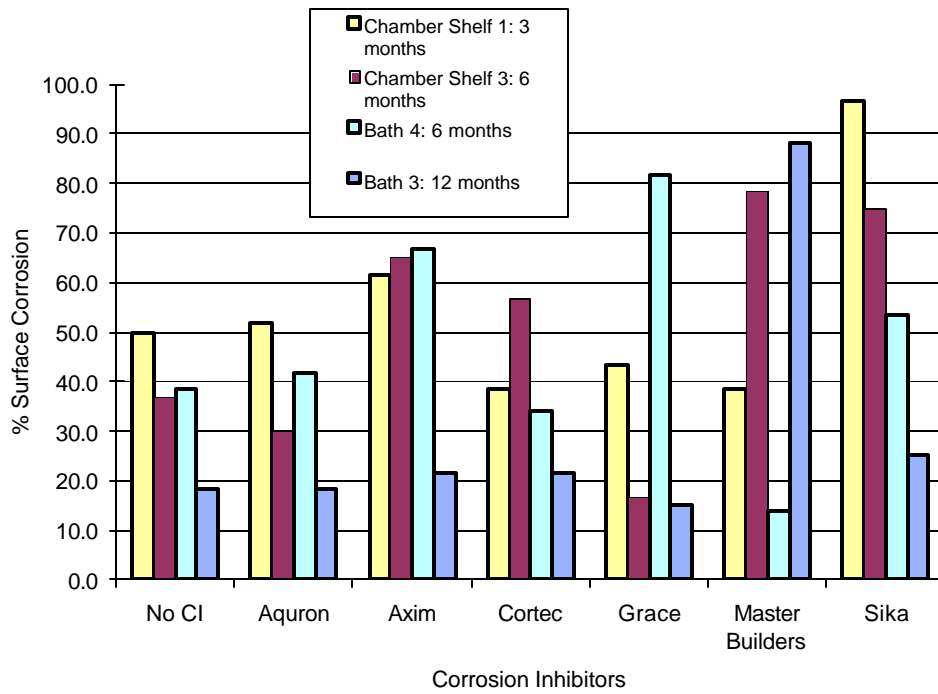
Figure E.51 Time Step of Surface Corrosion for 3.0% Chloride Post-Cracked Specimens

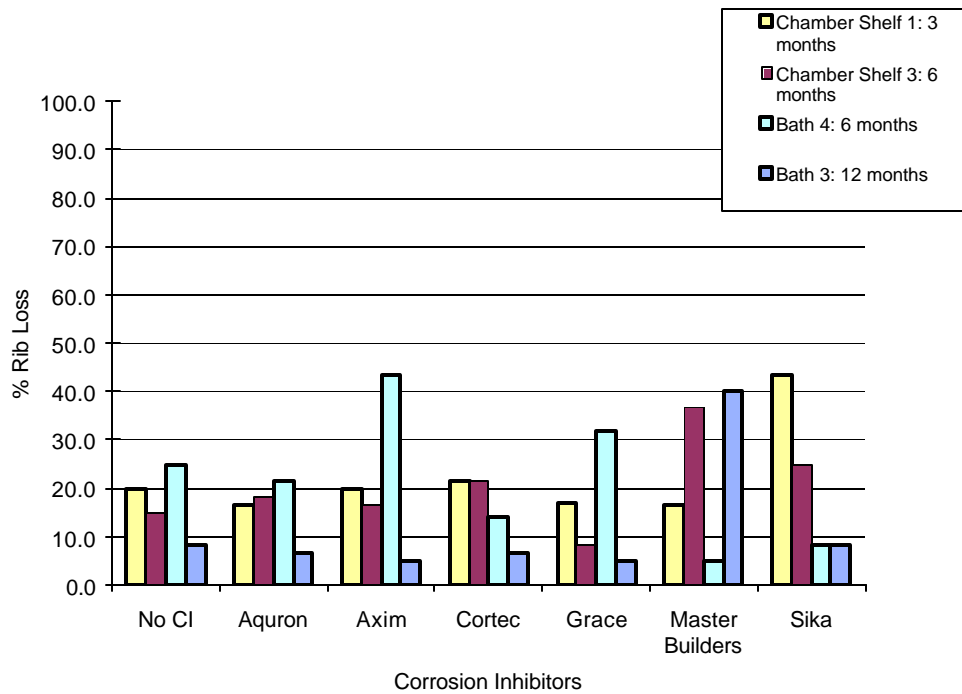
Figure E.52 Time Step of Rib Loss for 3.0% Chloride Post-Cracked Specimens
